LA-7019-MS

Examination of Copper or Nickel Coats on W-Base Composites

E. G. Zukas

los alamos
scientific laboratory
of the University of California
LOS ALAMOS, NEW MEXICO 87545

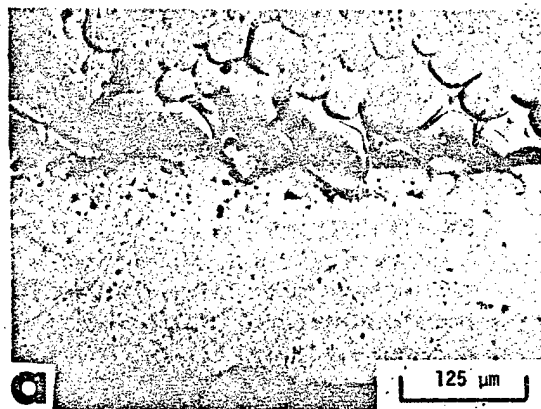
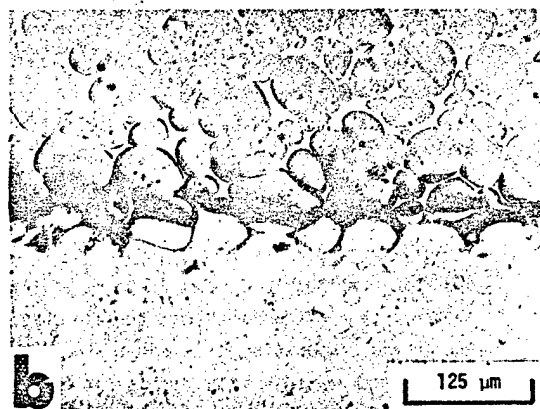
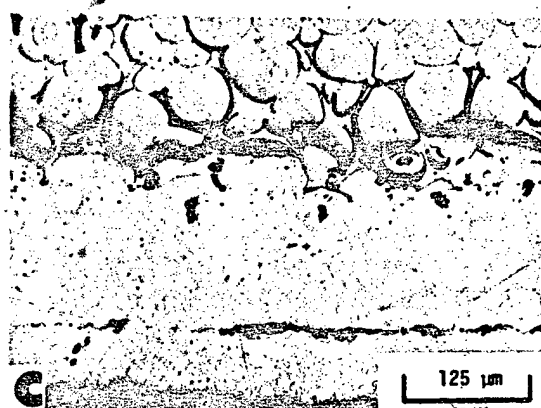
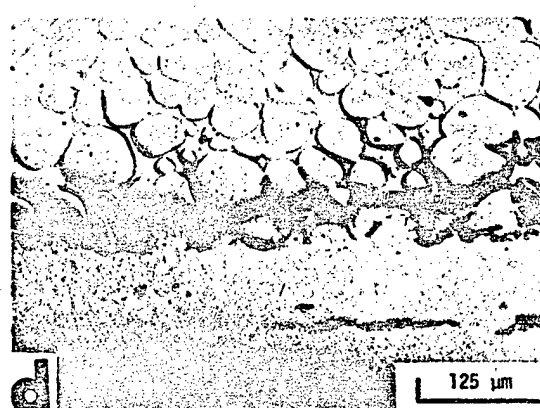
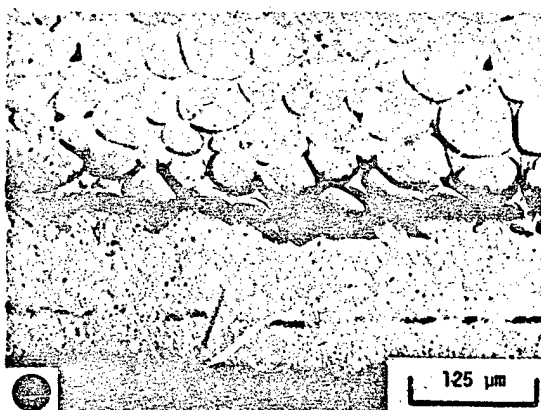
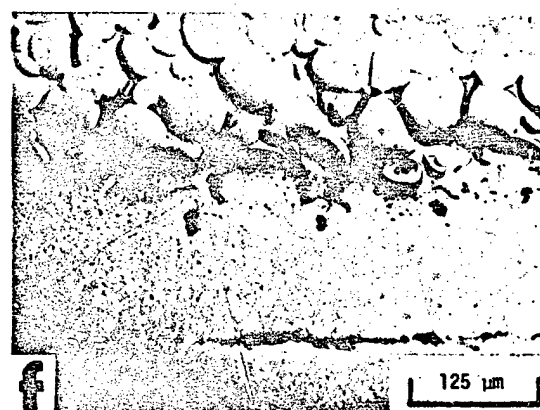
Fig. 1. Representative microstructures of the composite--copper junction showing bonding.

coats made it impossible to get rid of the polishing relief. Thus, all photomicrographs are of the specimens in the as-polished condition. Typical photomicrographs of the copper-coated composite are shown in Figs. 1 and 2. There are a number of pores in the copper, and a demarcation line about 70 μm from the coat surface indicating that perhaps the coating process was stopped and restarted (perhaps after checking coat thickness). Surprisingly, this boundary remains after heat-treatment at 923 K, whereas the boundary between the copper coat and composite matrix is not readily apparent. The base composite contains a few pores, but generally appears to be reasonably sound. However, as reported earlier,¹ the bend ductility angle was only 14° for the uncoated specimen, whereas the coated specimen passed through the bend-test fixture without fracturing. Specimens coated with nickel, and heat-treated for 1 h at 1223 K are shown in Figs. 3 and 4. In these specimens, 0.5% Pt was substituted for 0.5% W. These specimens contained quite a bit of porosity, with many pores on the surfaces after the specimens were machined and polished. The bend ductility angle for the uncoated material was 16°, not significantly different from the relatively pore-free material. The heat-treated specimens passed through the bend-test fixture without fracturing. The nickel coat, which appears to have alloyed with the composite matrix, spans the gaps at the pores, thereby decreasing their effectiveness as stress raisers and reducing their tendency to promote fracture.

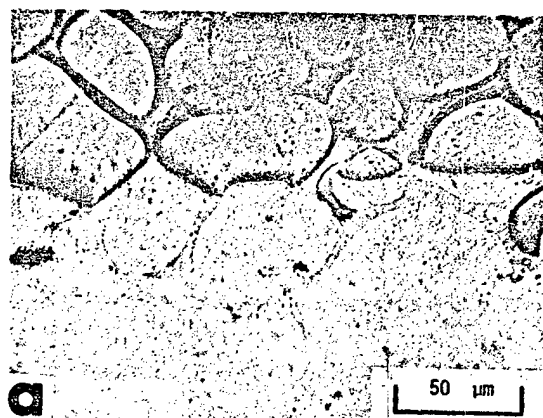
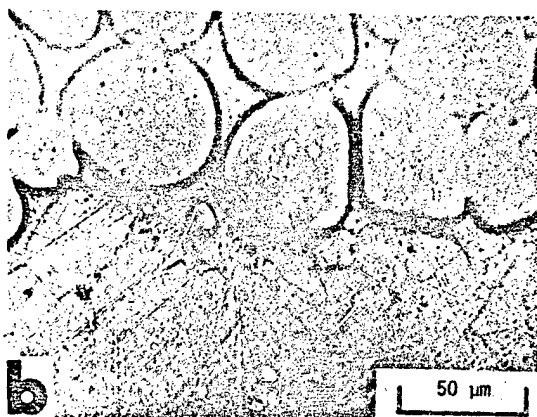
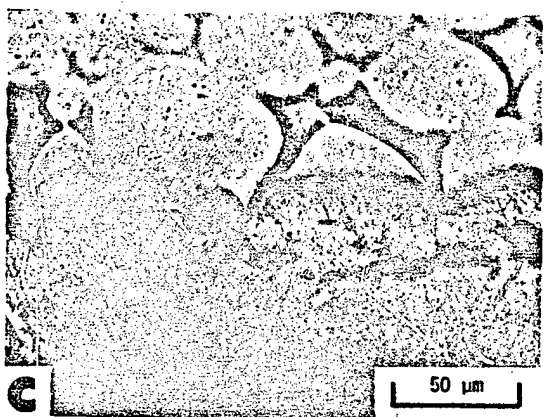
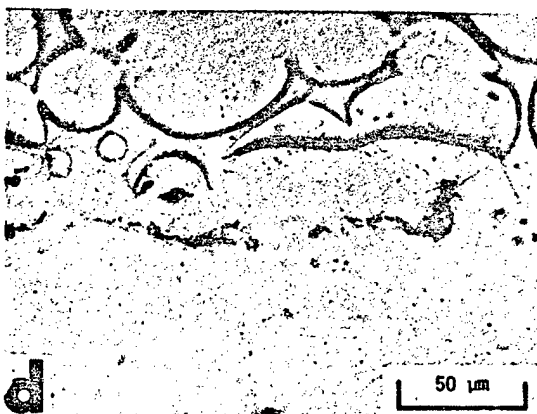
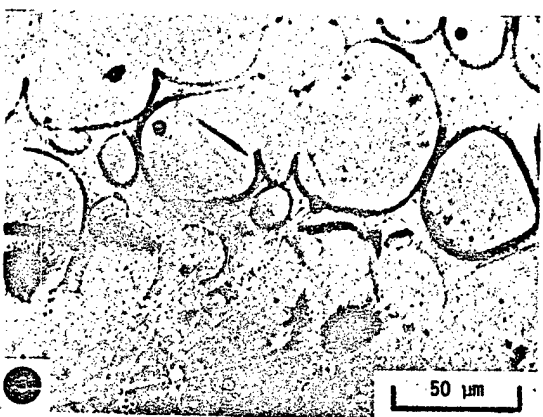
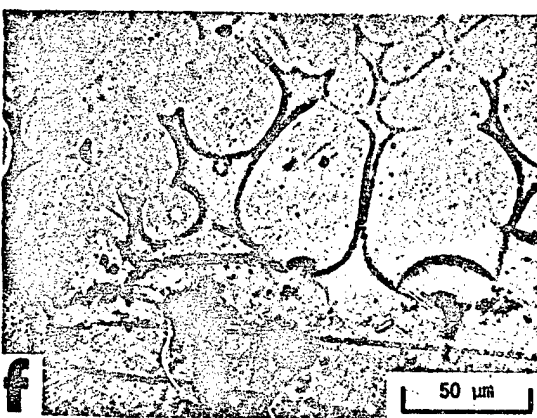
Fig. 2. Additional microstructures of the composite--copper junction.

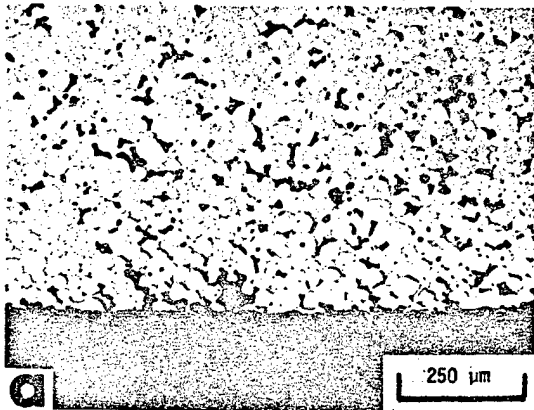
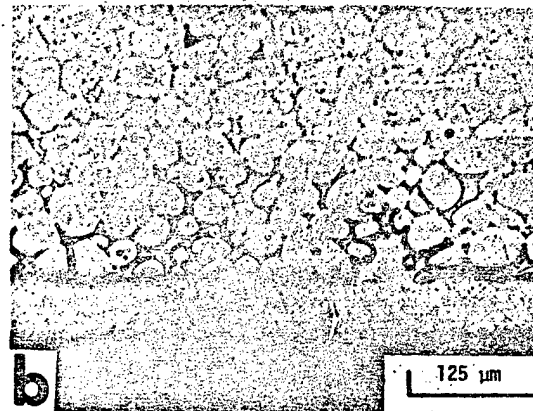
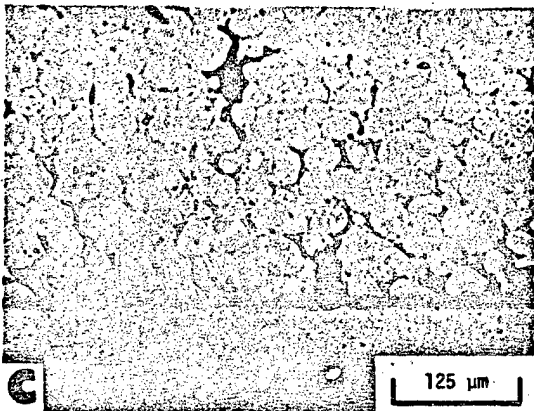
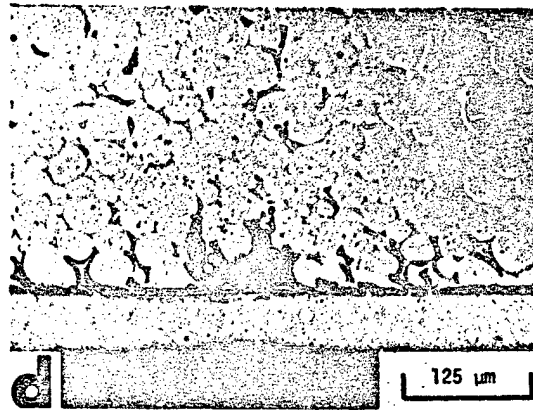
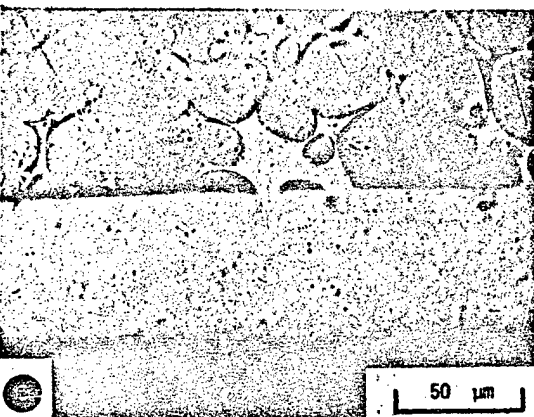
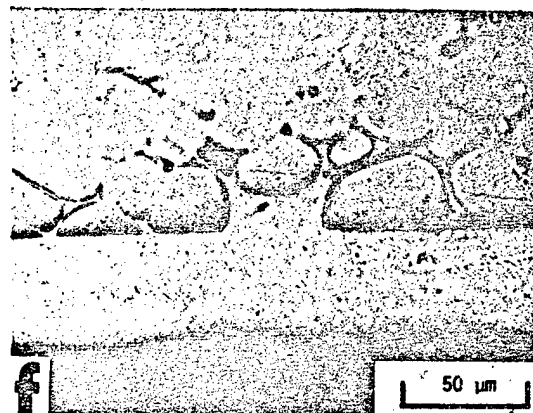
Fig. 3. Representative microstructures of the composite--nickel junction showing bonding as well as spanning of pores by the coat.

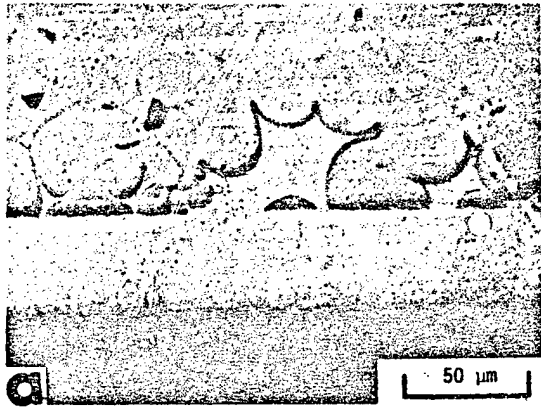
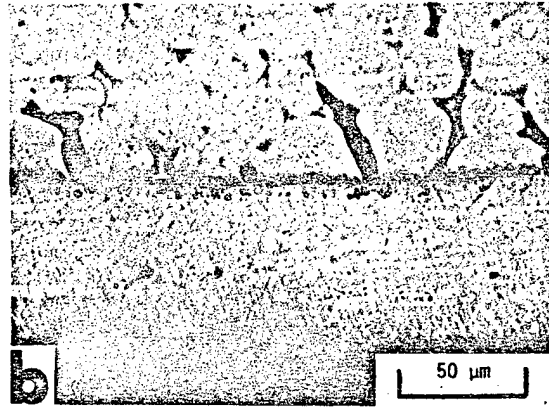
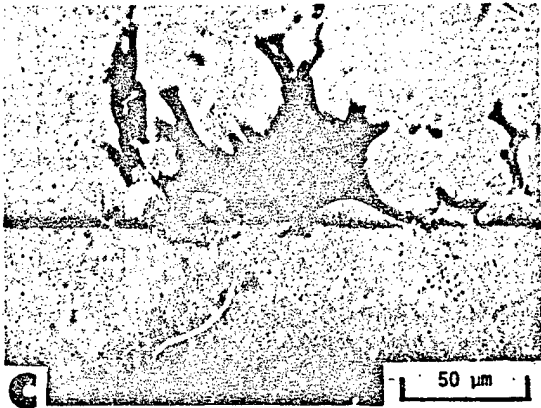
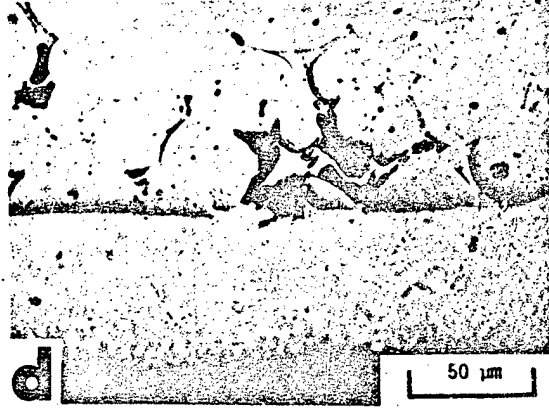
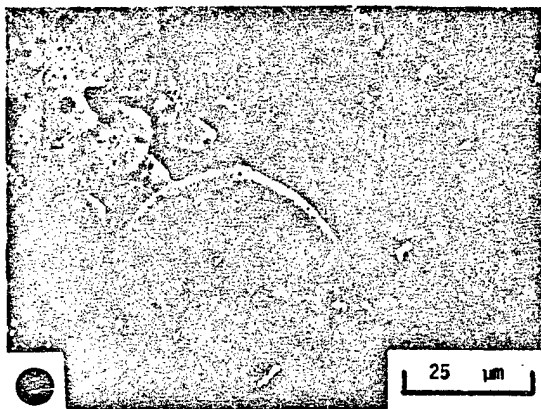
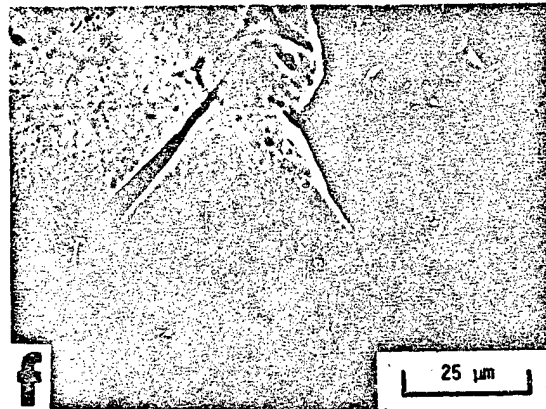
Fig. 4. Additional microstructures of the composite--nickel junction.

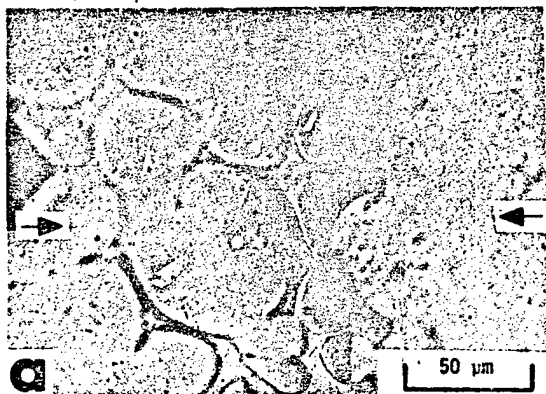
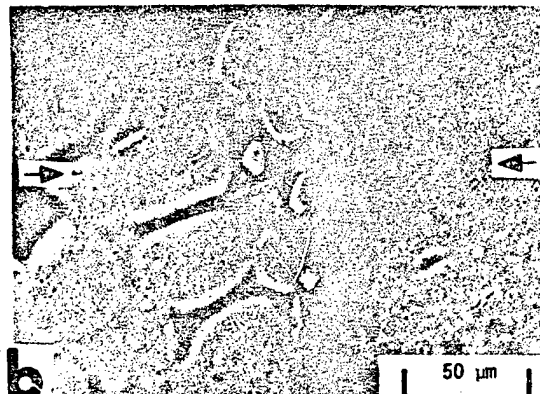
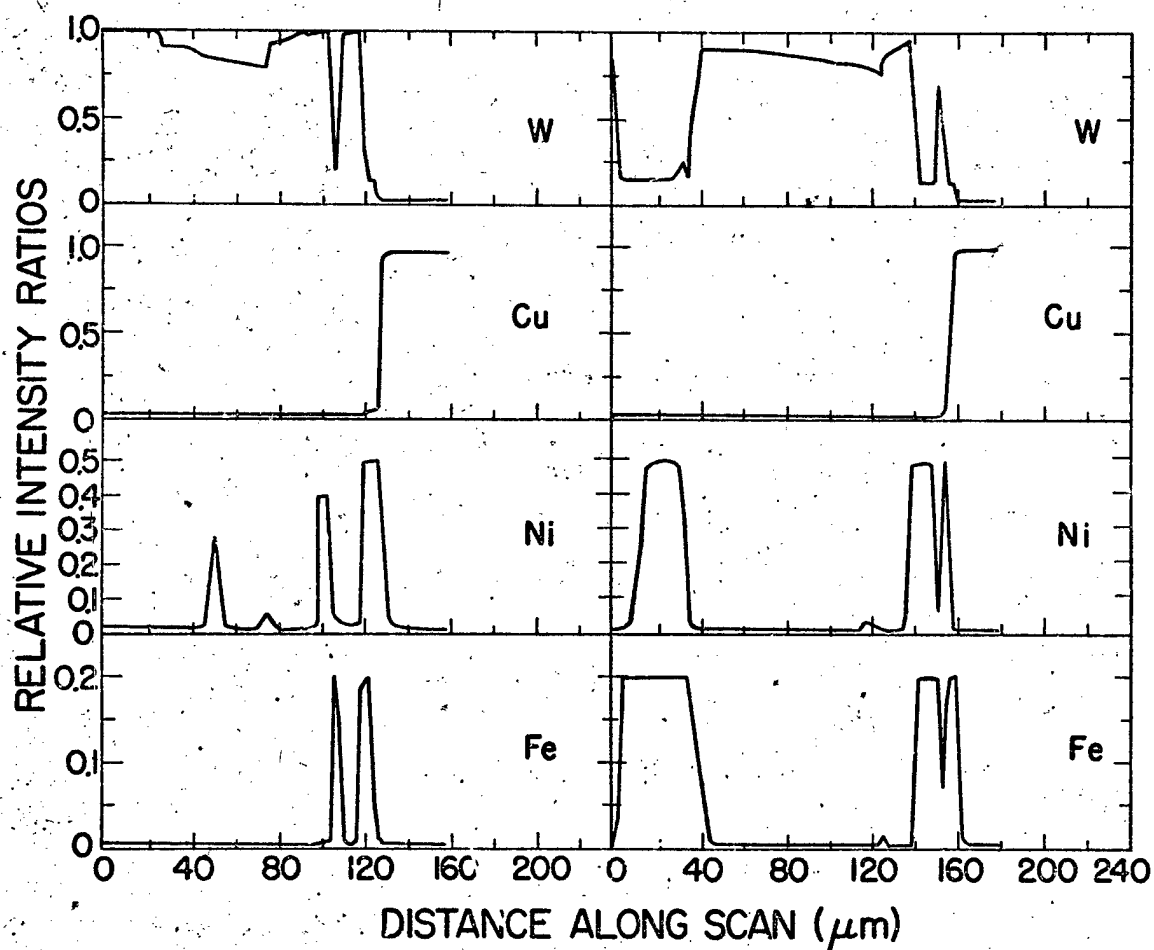
Fig. 5. Microprobe analysis of scans #1 and #2 across composite--copper junction.

Eight individual microprobe scans for the 95% W-35% Ni-1.5% Fe composite coated with copper followed by heat-treating in vacuum for 1 h at 923 K are shown in Figs. 5 through 8. Arrows are used to denote the scan path but do not define the starting point. Since the spheroids are essentially pure W, the scan paths can be matched to position in the structure. The interdiffusion appears to be between the nickel in the matrix and the copper coat. The width of the alloy band is about 6 μm , in fair agreement with what should be expected based on the diffusivity for the times and temperatures used. The important point here is that there is chemical bonding between the copper coat and the base composite.

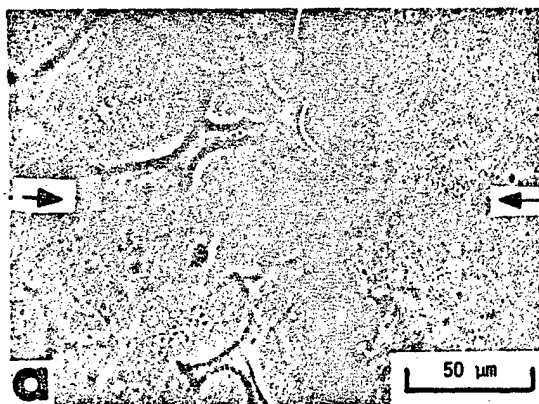
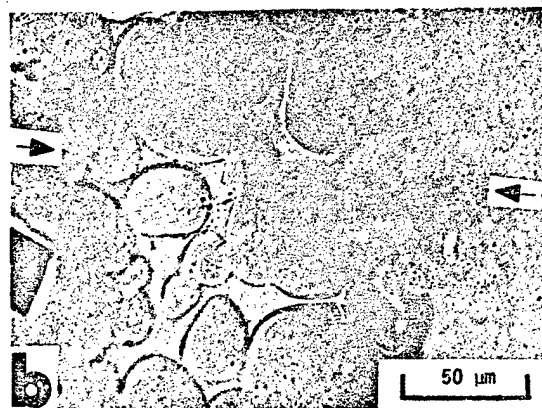
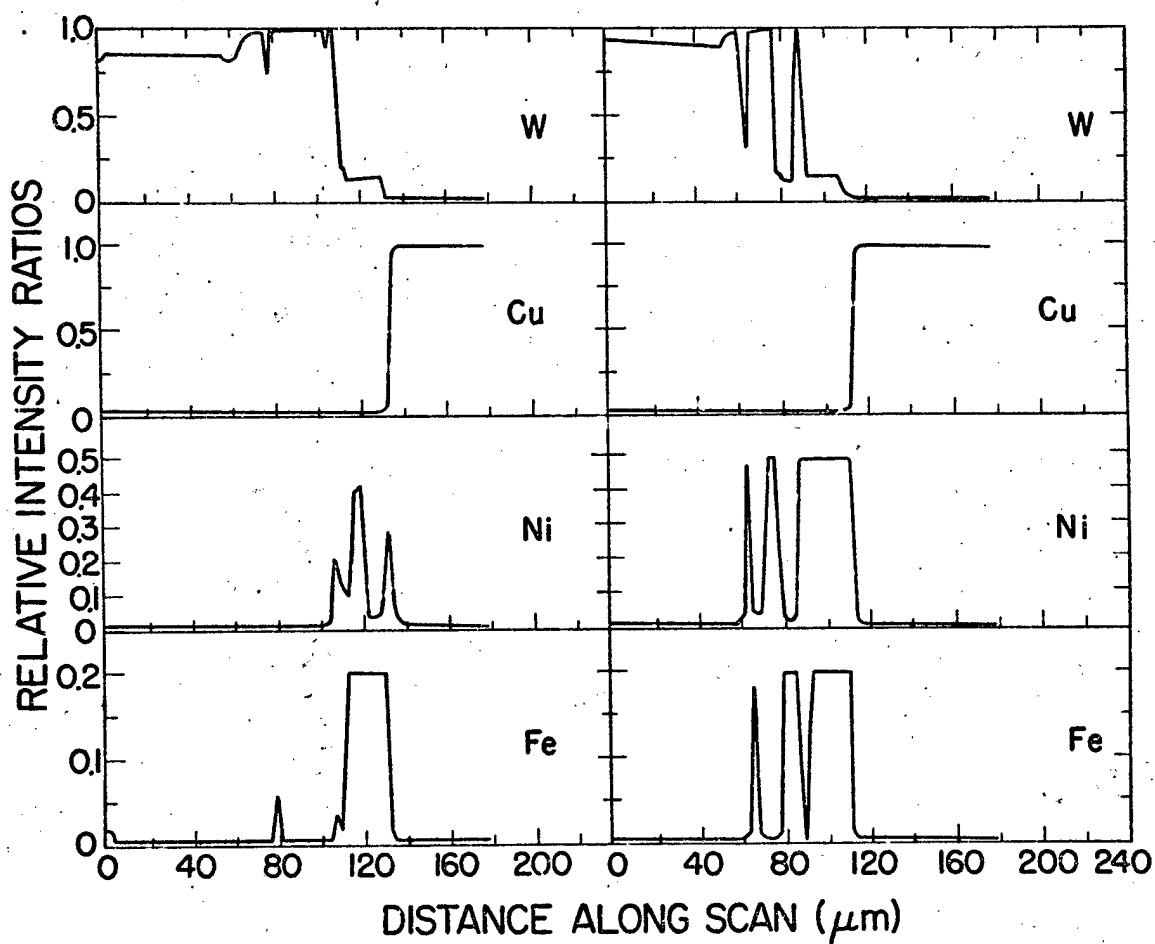
Fig. 6. Microprobe analysis of scans #3 and #4 across composite--copper junction.

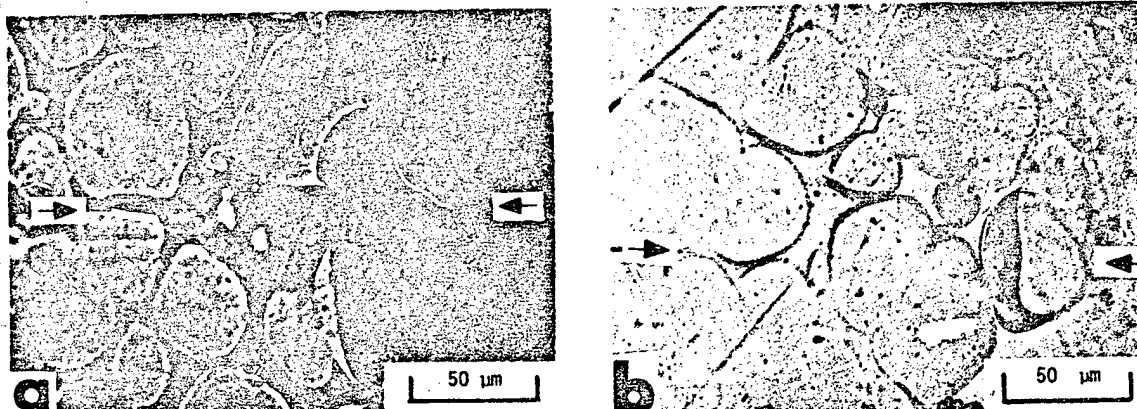
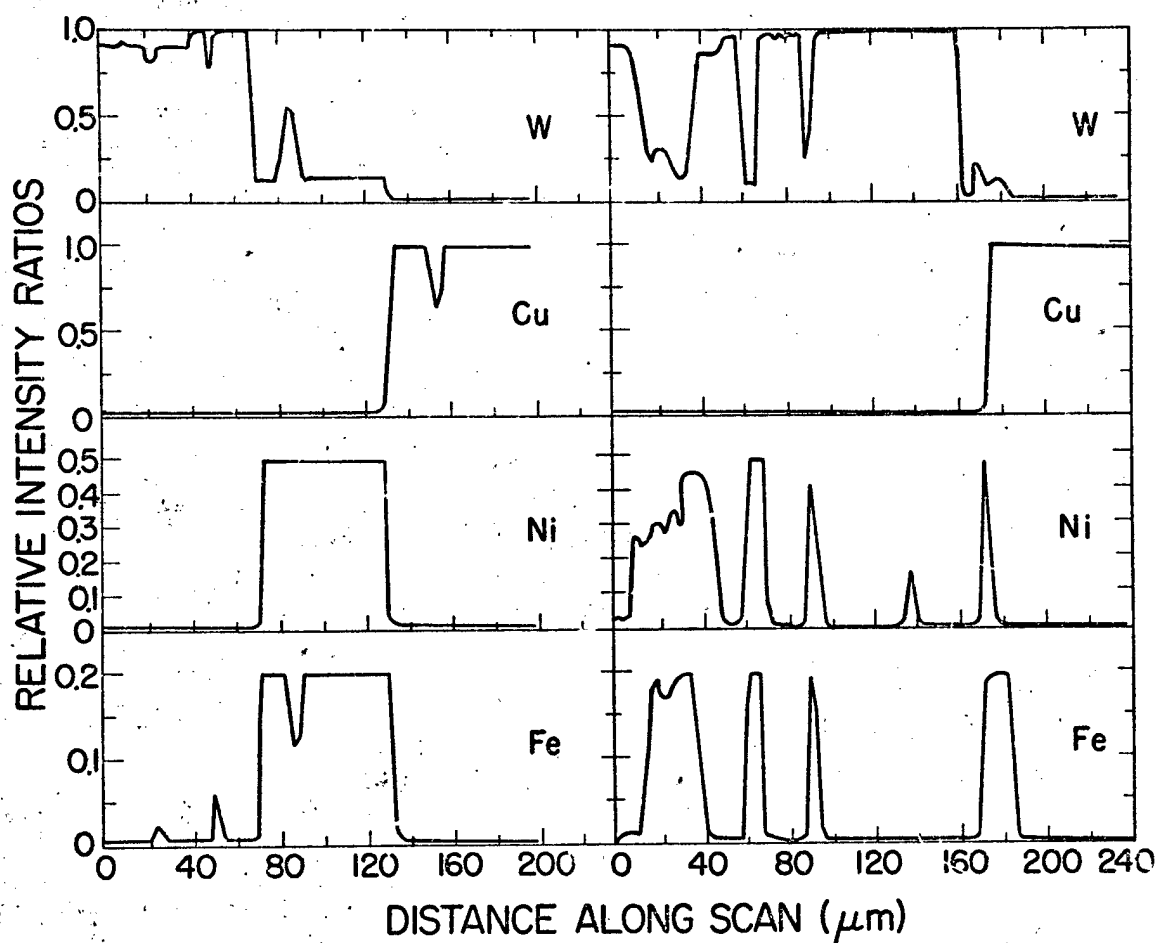
Fig. 7. Microprobe analysis of scans #5 and #6 across composite--copper junction.

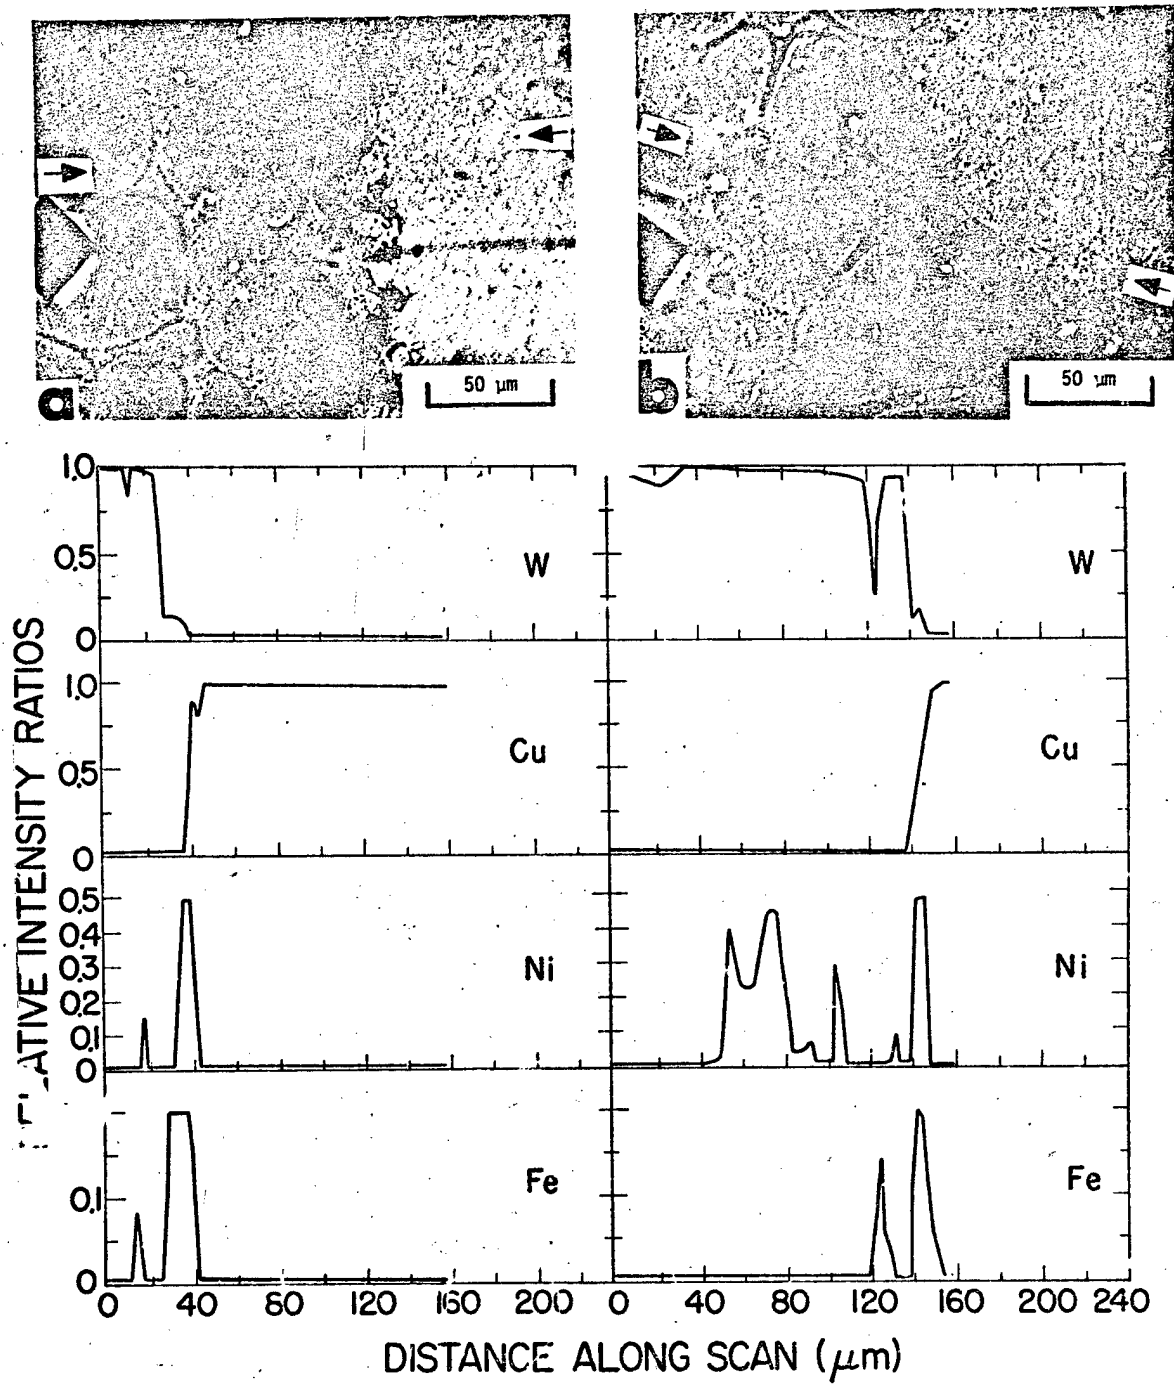
Fig. 8. Microprobe analysis of scans #7 and #8 across composite--copper junction.

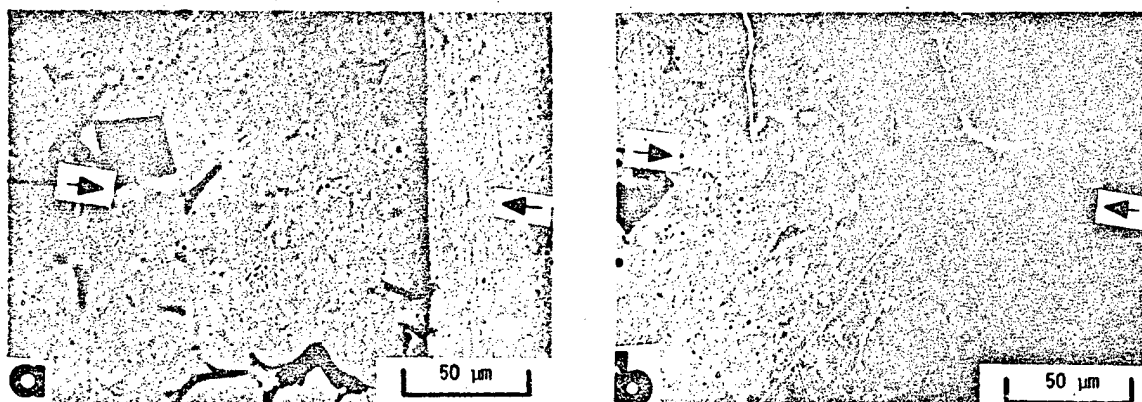
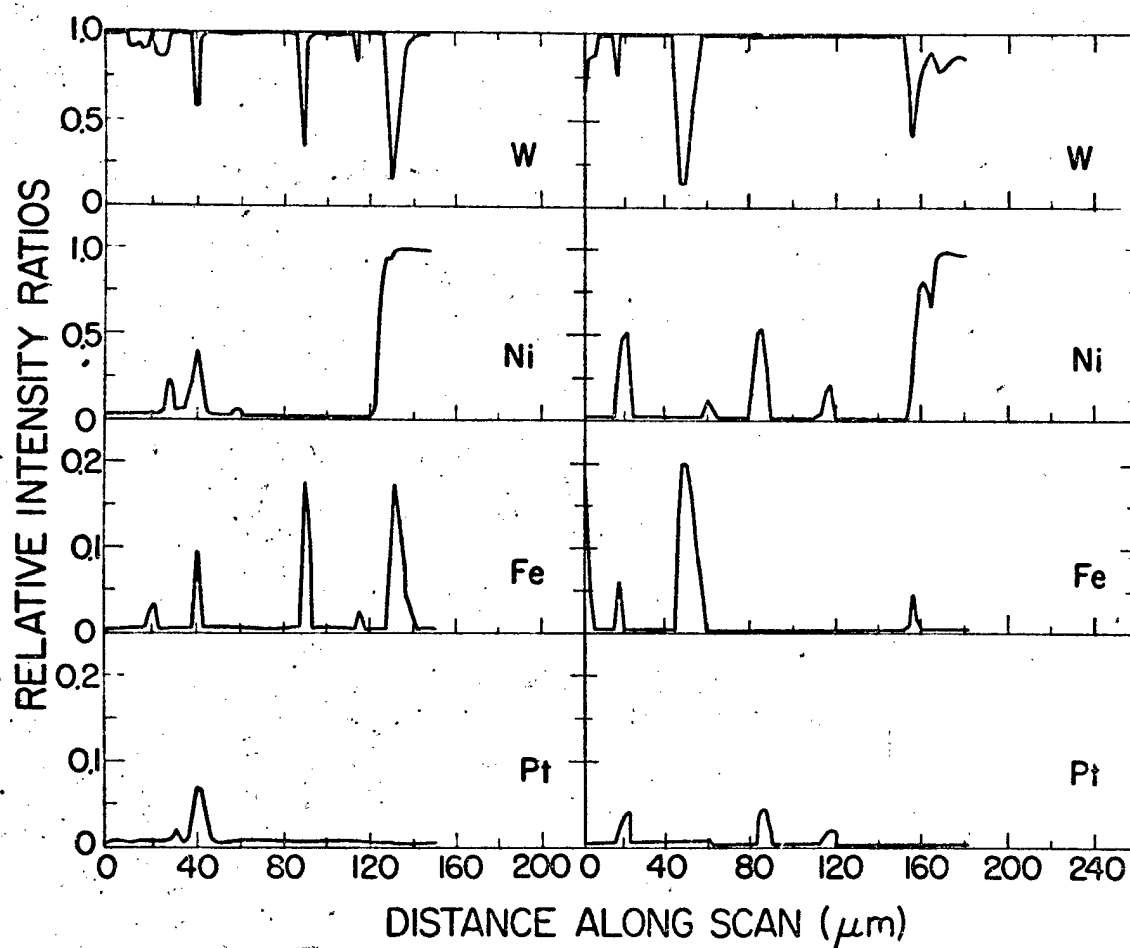
Fig. 9. Microprobe analysis of scans #1 and #2 across composite--nickel junction.

Eight individual microprobe scans for the 94.5% W-3.5% Ni-1.5% Fe-0.5% Pt composite coated with nickel followed by heat-treating in vacuum for 1 h at 1223 K are shown in Figs. 9 through 12. The analytical results show that there is diffusion between the nickel coat and the base composite. In some cases, the diffusion layer seems to be quite wide, but this should be expected in view of the relatively high heat-treatment temperature. However, there is one aspect of the results which may not appear reasonable. In some instances, W diffuses readily into the nickel coat, whereas at other locations, it does not. The same situation occurs with Fe. This behavior is probably similar to that observed in the activated sintering of W with Ni where very rapid diffusion takes place along grain boundaries and along certain crystallographic planes.^{3,4}

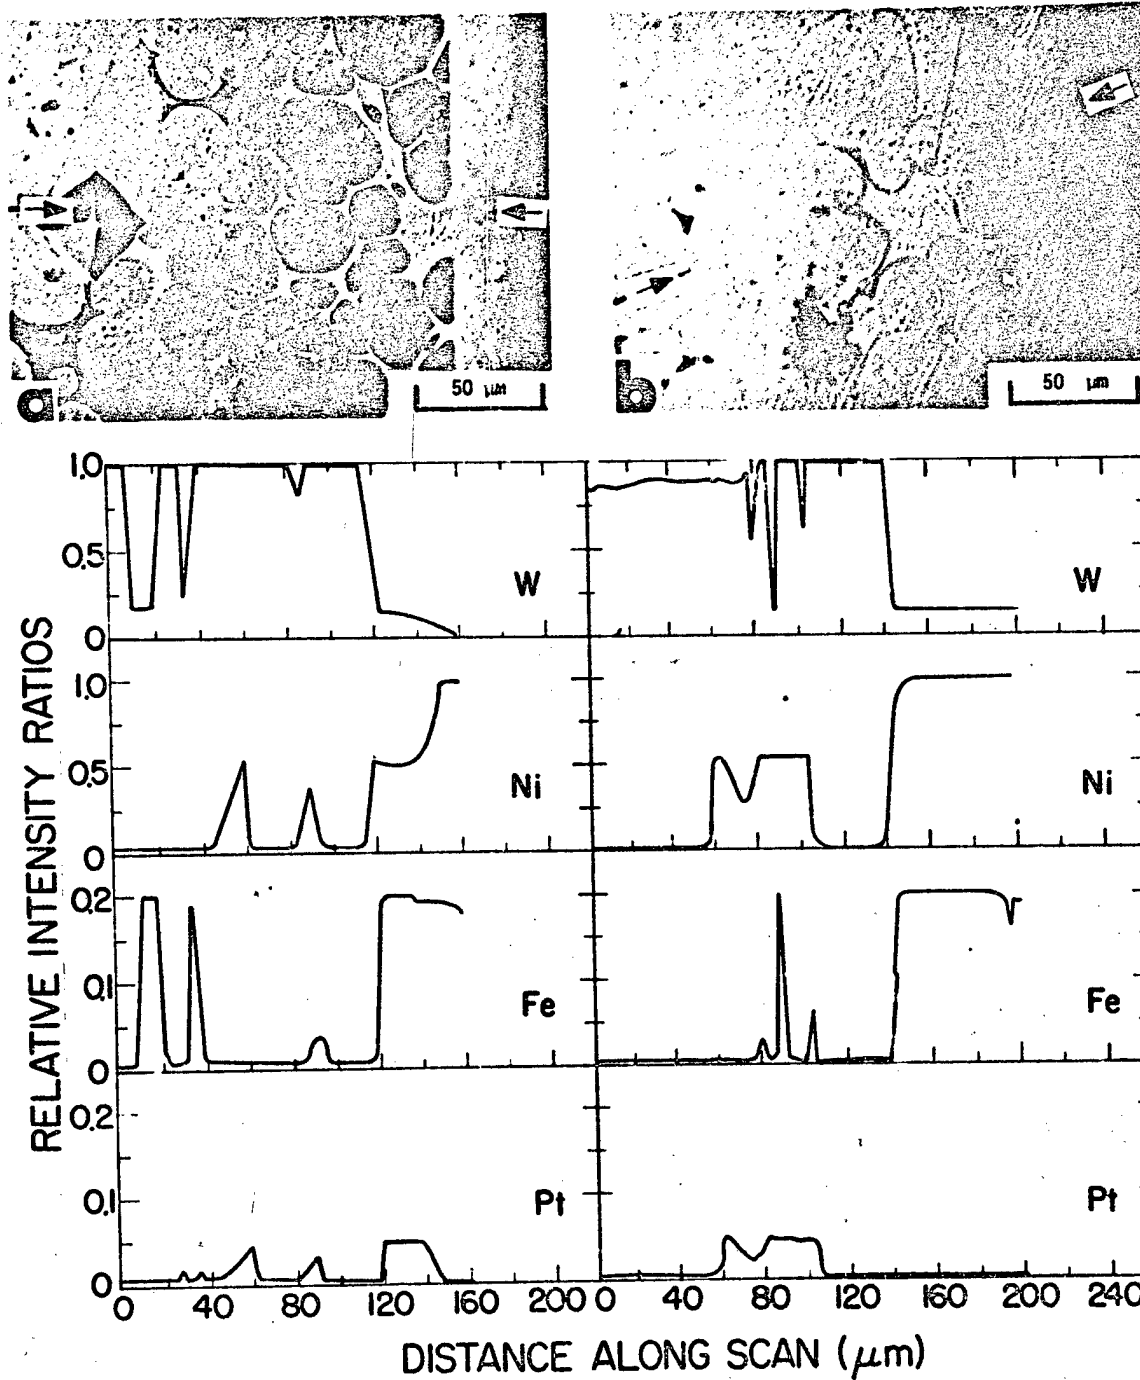
Fig. 10. Microprobe analysis of scans #3 and #4 across composite-nickel junction.

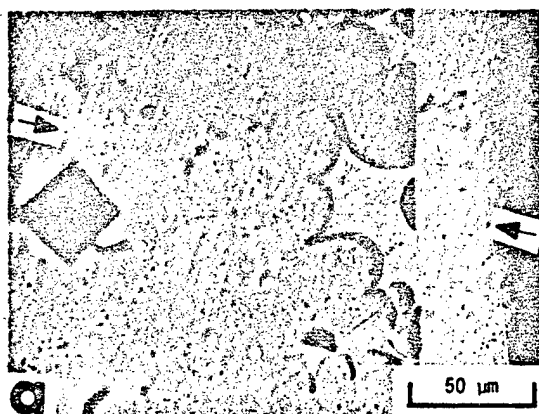
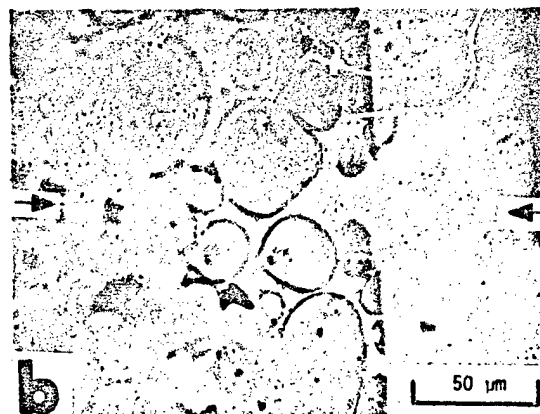
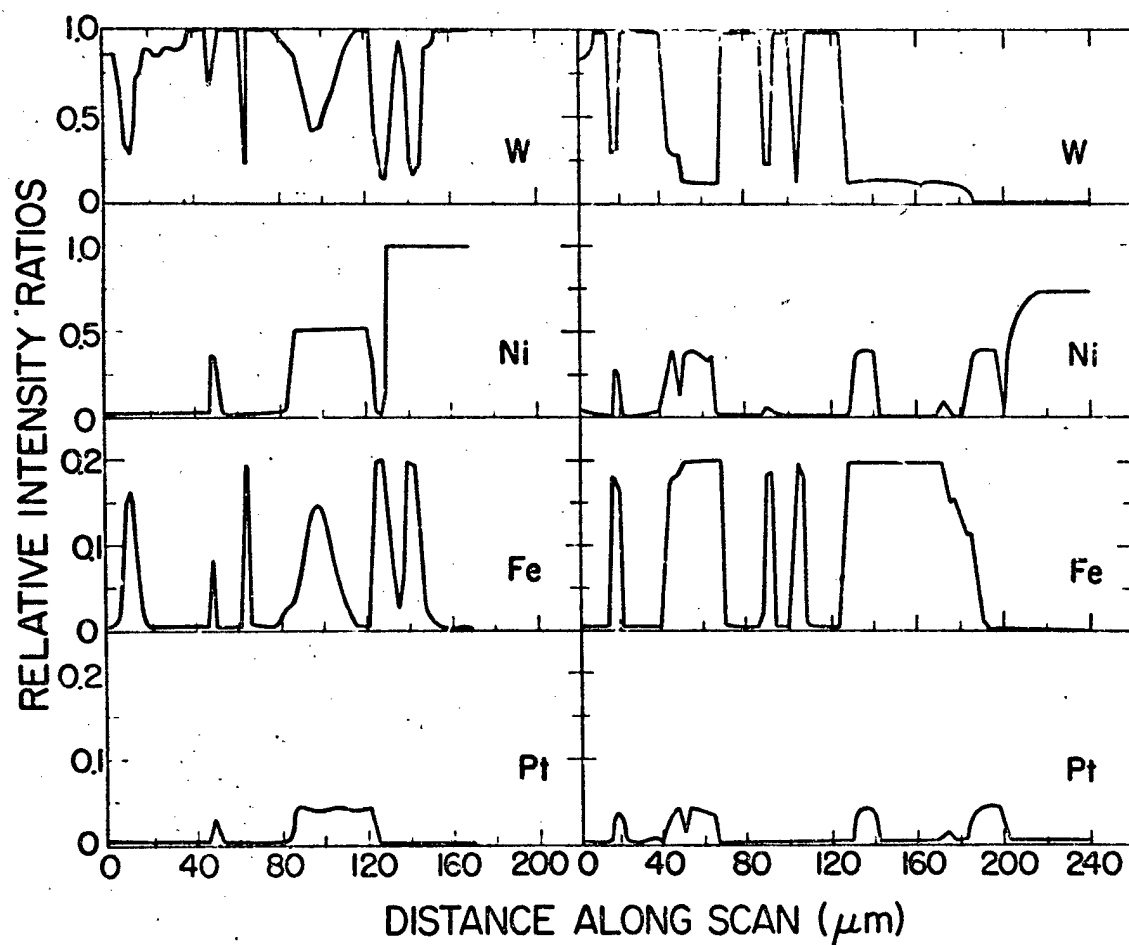
Fig. 11. Microprobe analysis of scans #5 and #6 across composite--nickel junction.

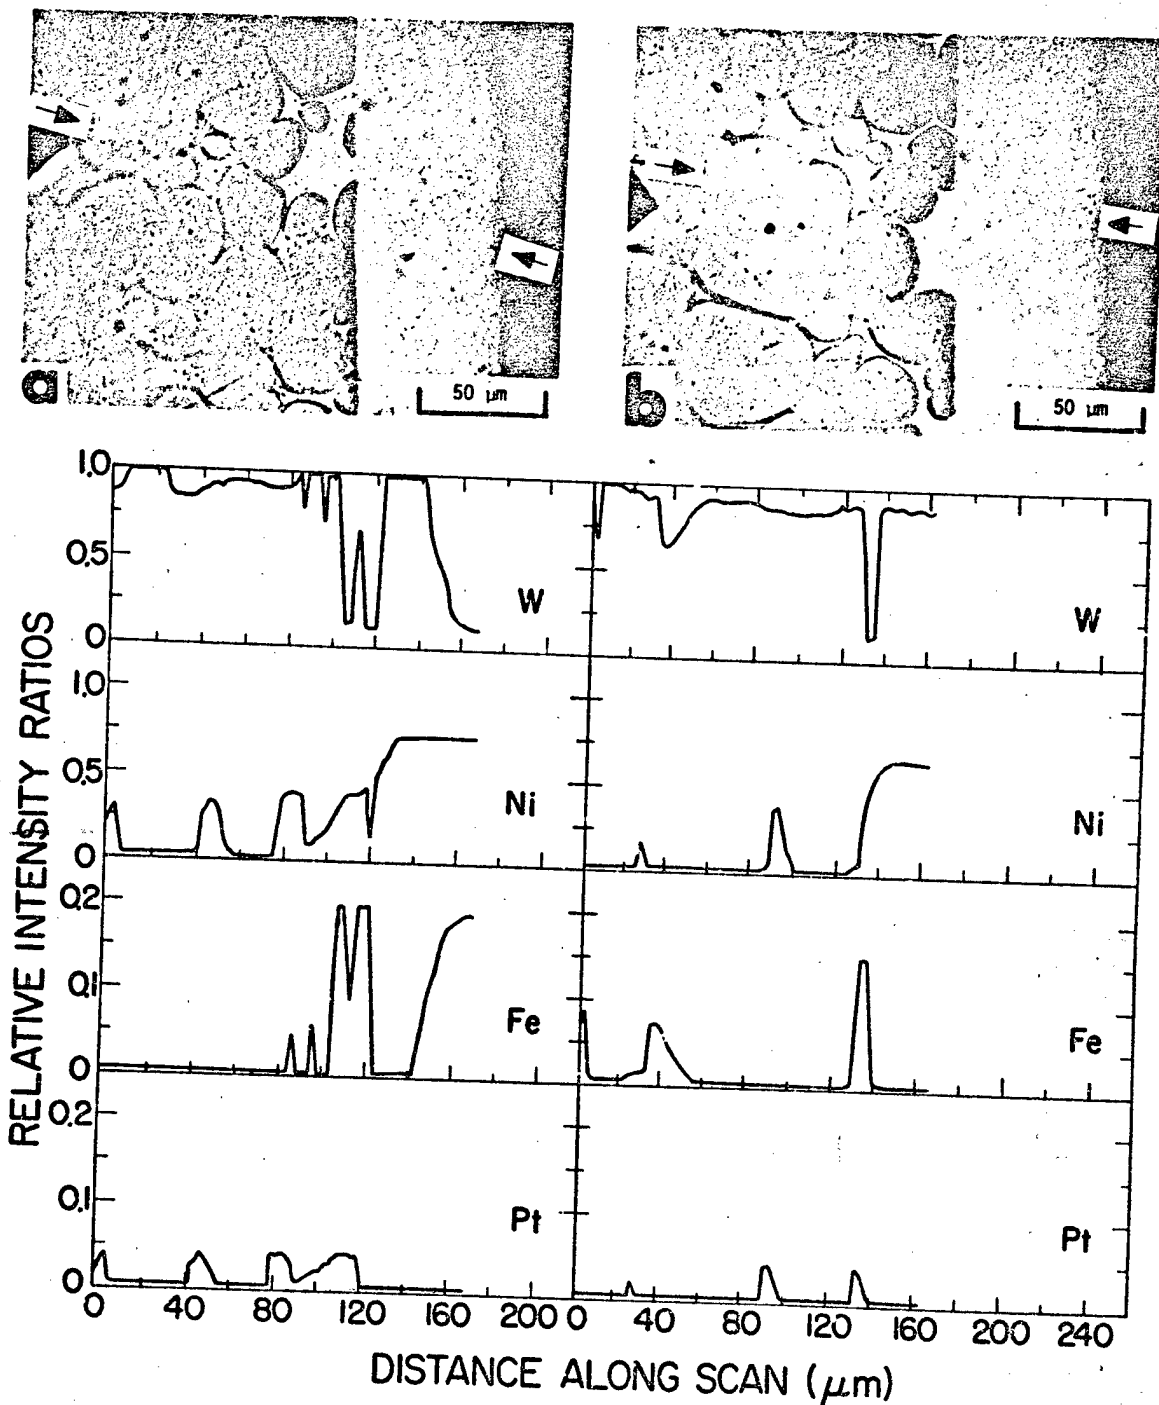
Fig. 12. Microprobe analysis of scans #7 and #8 across composite--nickel junction.
